# Genius Radiator Valve error codes

There is an error code showing on the Genius Radiator Valve

The error codes (DA-WRV-E)

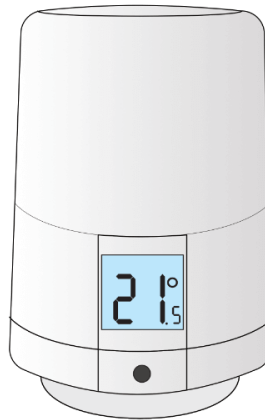
The error codes are as follows:

- **E1** - Top temperature sensor has a problem
- **E2** - Side temperature sensor has a problem
- **E6** - Motor has a problem
- **E8** - Communication error
- **E9** - Valve cannot close

1. Remove and replace the batteries in the Genius Radiator Valve as described in [this article](#).
2. When the Genius Radiator Valve has restarted, if the error has persisted the device has developed a fault and needs to be replaced. Contact Genius Hub if your device is [under warranty](#).

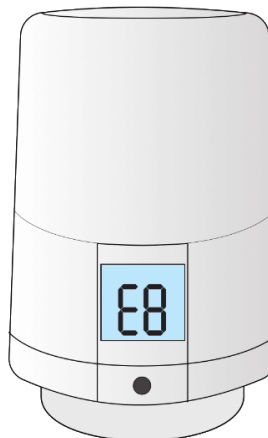
## E8 error

The Genius Radiator Valve shows the 'E8' 'communication error' if it tries to communicate with the Genius Hub a number of times and fails.

The Genius Radiator Valve will naturally come out of 'E8' when the communication with the Genius Hub is re-established, through the only tries to communicate with the Genius Hub about every 30 minutes when in 'E8' so this may take a number of hours.

To remove the 'E8' error from the valve immediately, so you can change the temperature on the valve, you have to remove one of the batteries for 30 seconds and put it back in again. This communication problem may have been caused if a Genius Smart Plug near the valve has become unplugged or the Genius Hub has been turned off.

If the problem persists see the article: [How to - Genius Position the Genius Smart Plugs](#).

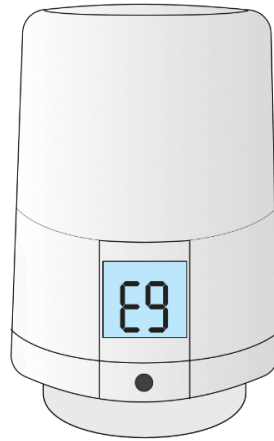
## E9 error

The Genius Radiator Valve shows the 'E9' 'Valve closing error' if it tries to close the flow of water through the radiator a number of times and fails. Unmount and remount the Genius Radiator Valve to see if this fixes the problem.

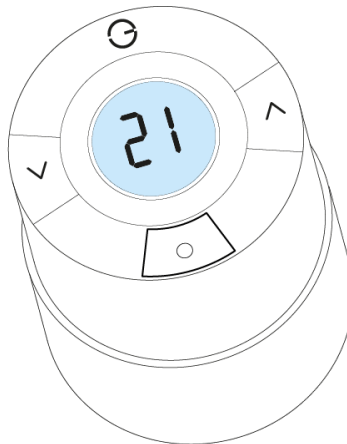
## The error codes (DA-WRV-C)

The error codes are as follows:

- **E1** - Front temperature sensor has a problem
- **E2** - Back temperature sensor has a problem
- **E3** - Motor has a problem
- **E5** - Communication error

1. Remove and replace the batteries in the Genius Radiator Valve as described in [this article](#).
2. When the Genius Radiator Valve has restarted, if the error has persisted the device has developed a fault and needs to be replaced. Contact Genius Hub if your device is [under warranty](#).

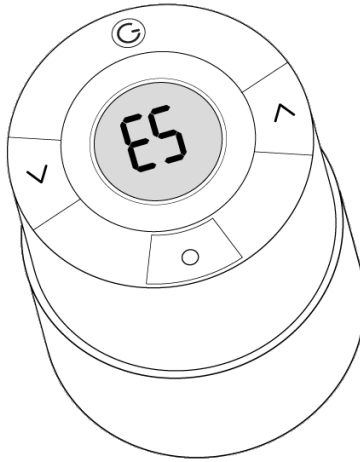
## E5 error

The Genius Radiator Valve shows the 'E5' 'communication error' if it tries to communicate with the Genius Hub a number of times and fails.

The Genius Radiator Valve will naturally come out of 'E5' when the communication with the Genius Hub is re-established, through the only tries to communicate with the Genius Hub about every 30 minutes when in 'E5' so this may take a number of hours.

To remove the 'E5' error from the valve immediately, so you can change the temperature on the valve, you have to remove one of the batteries for 30 seconds and put it back in again. This communication problem may have been caused if a Genius Smart Plug near the valve has become unplugged or the Genius Hub has been turned off.

If the problem persists see the article: [How to - Genius Position the Genius Smart Plugs](#).
